# Floods in South Australia's Arid Zone – Experiences and Challenges

David Kemp – DTEI, SA

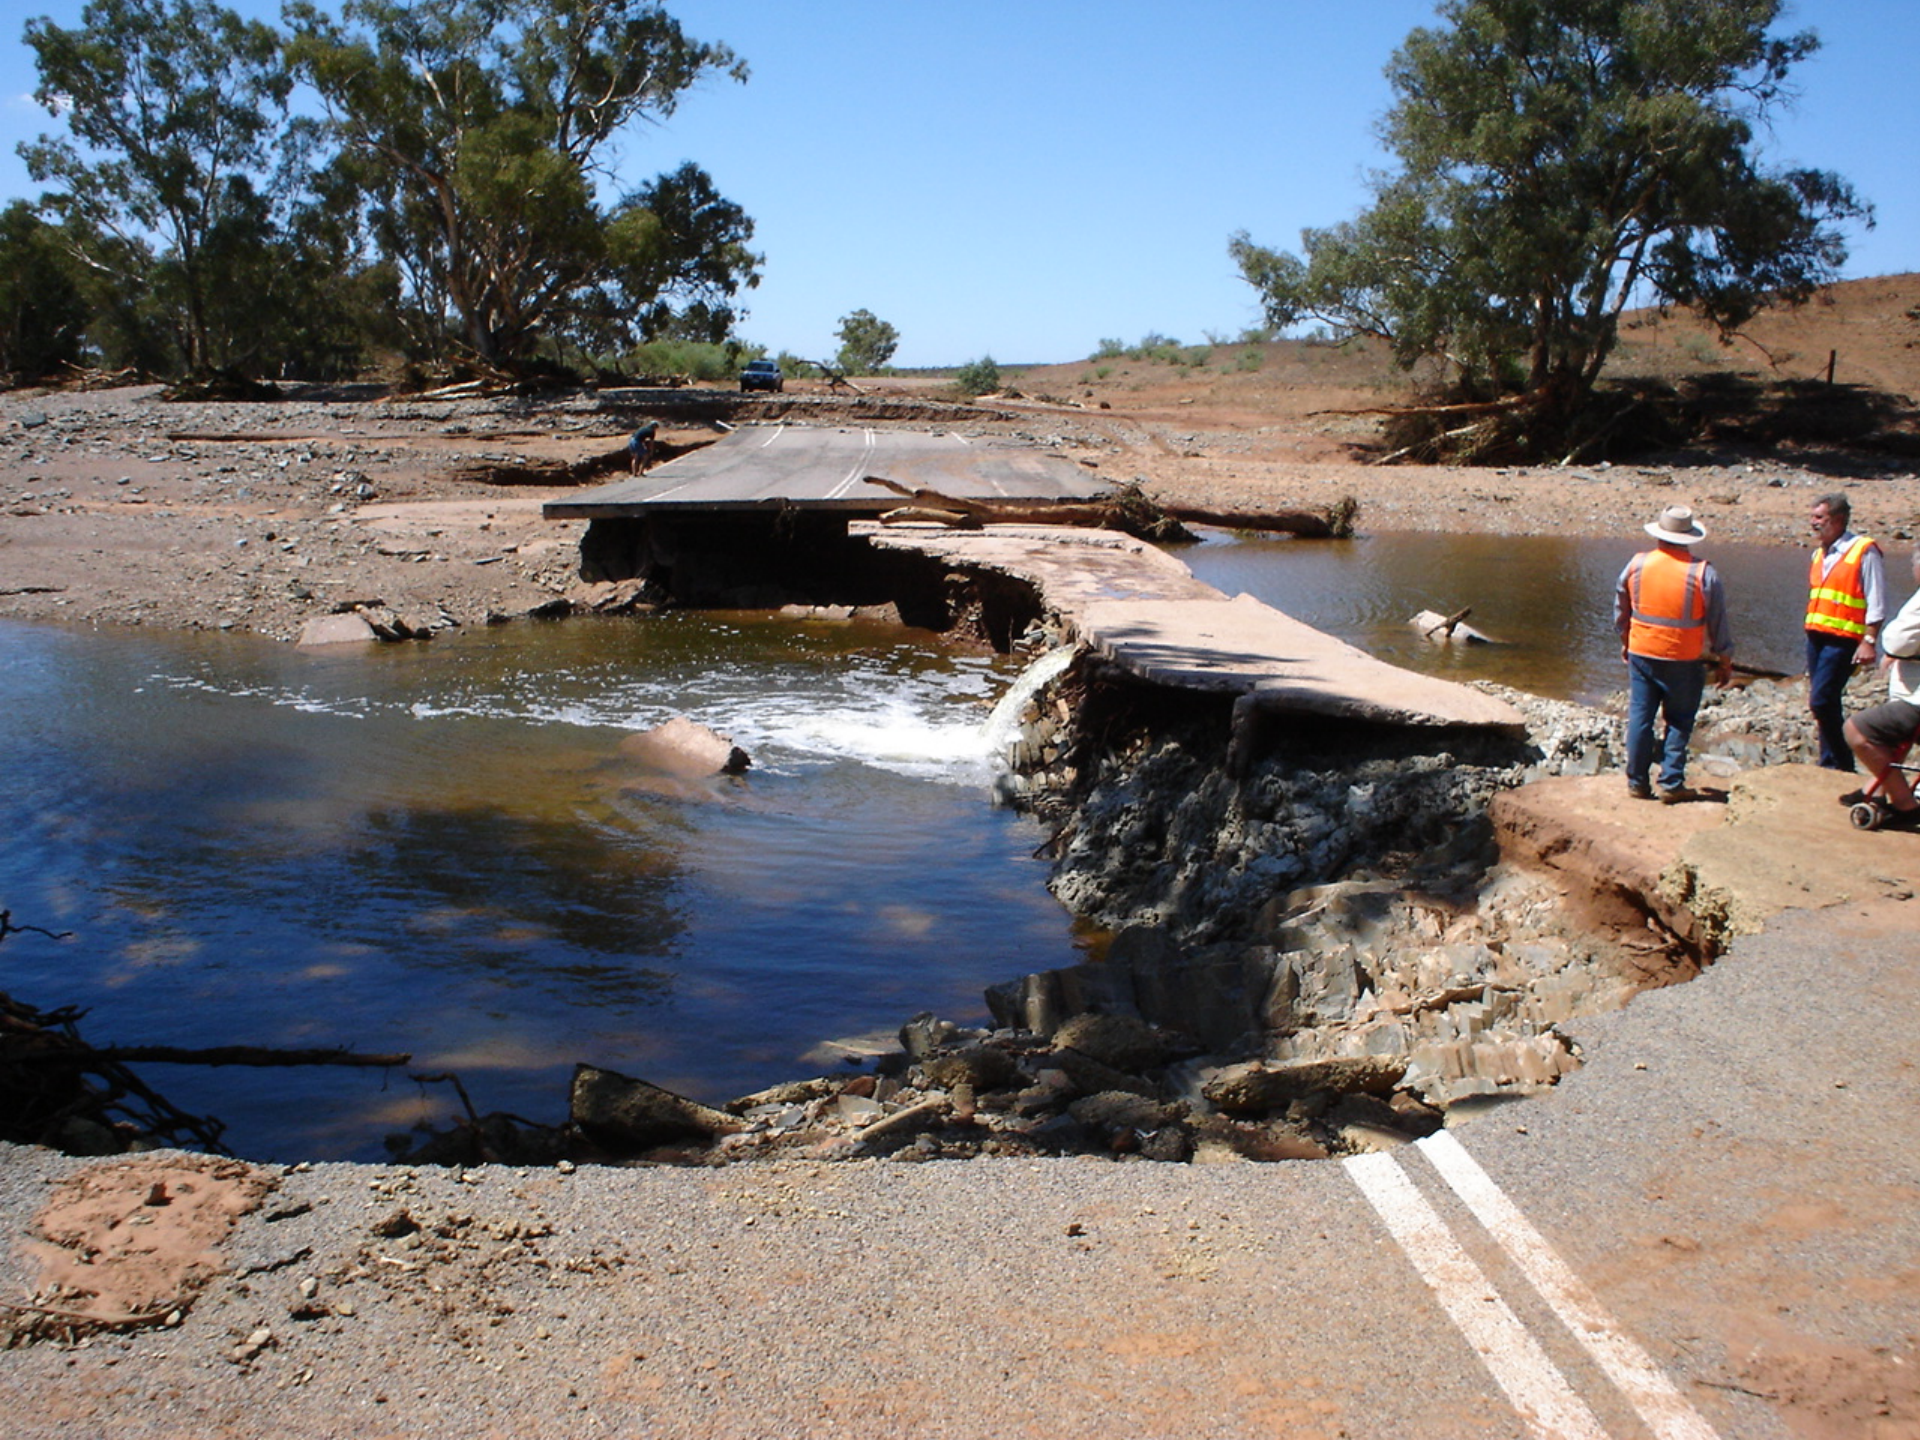
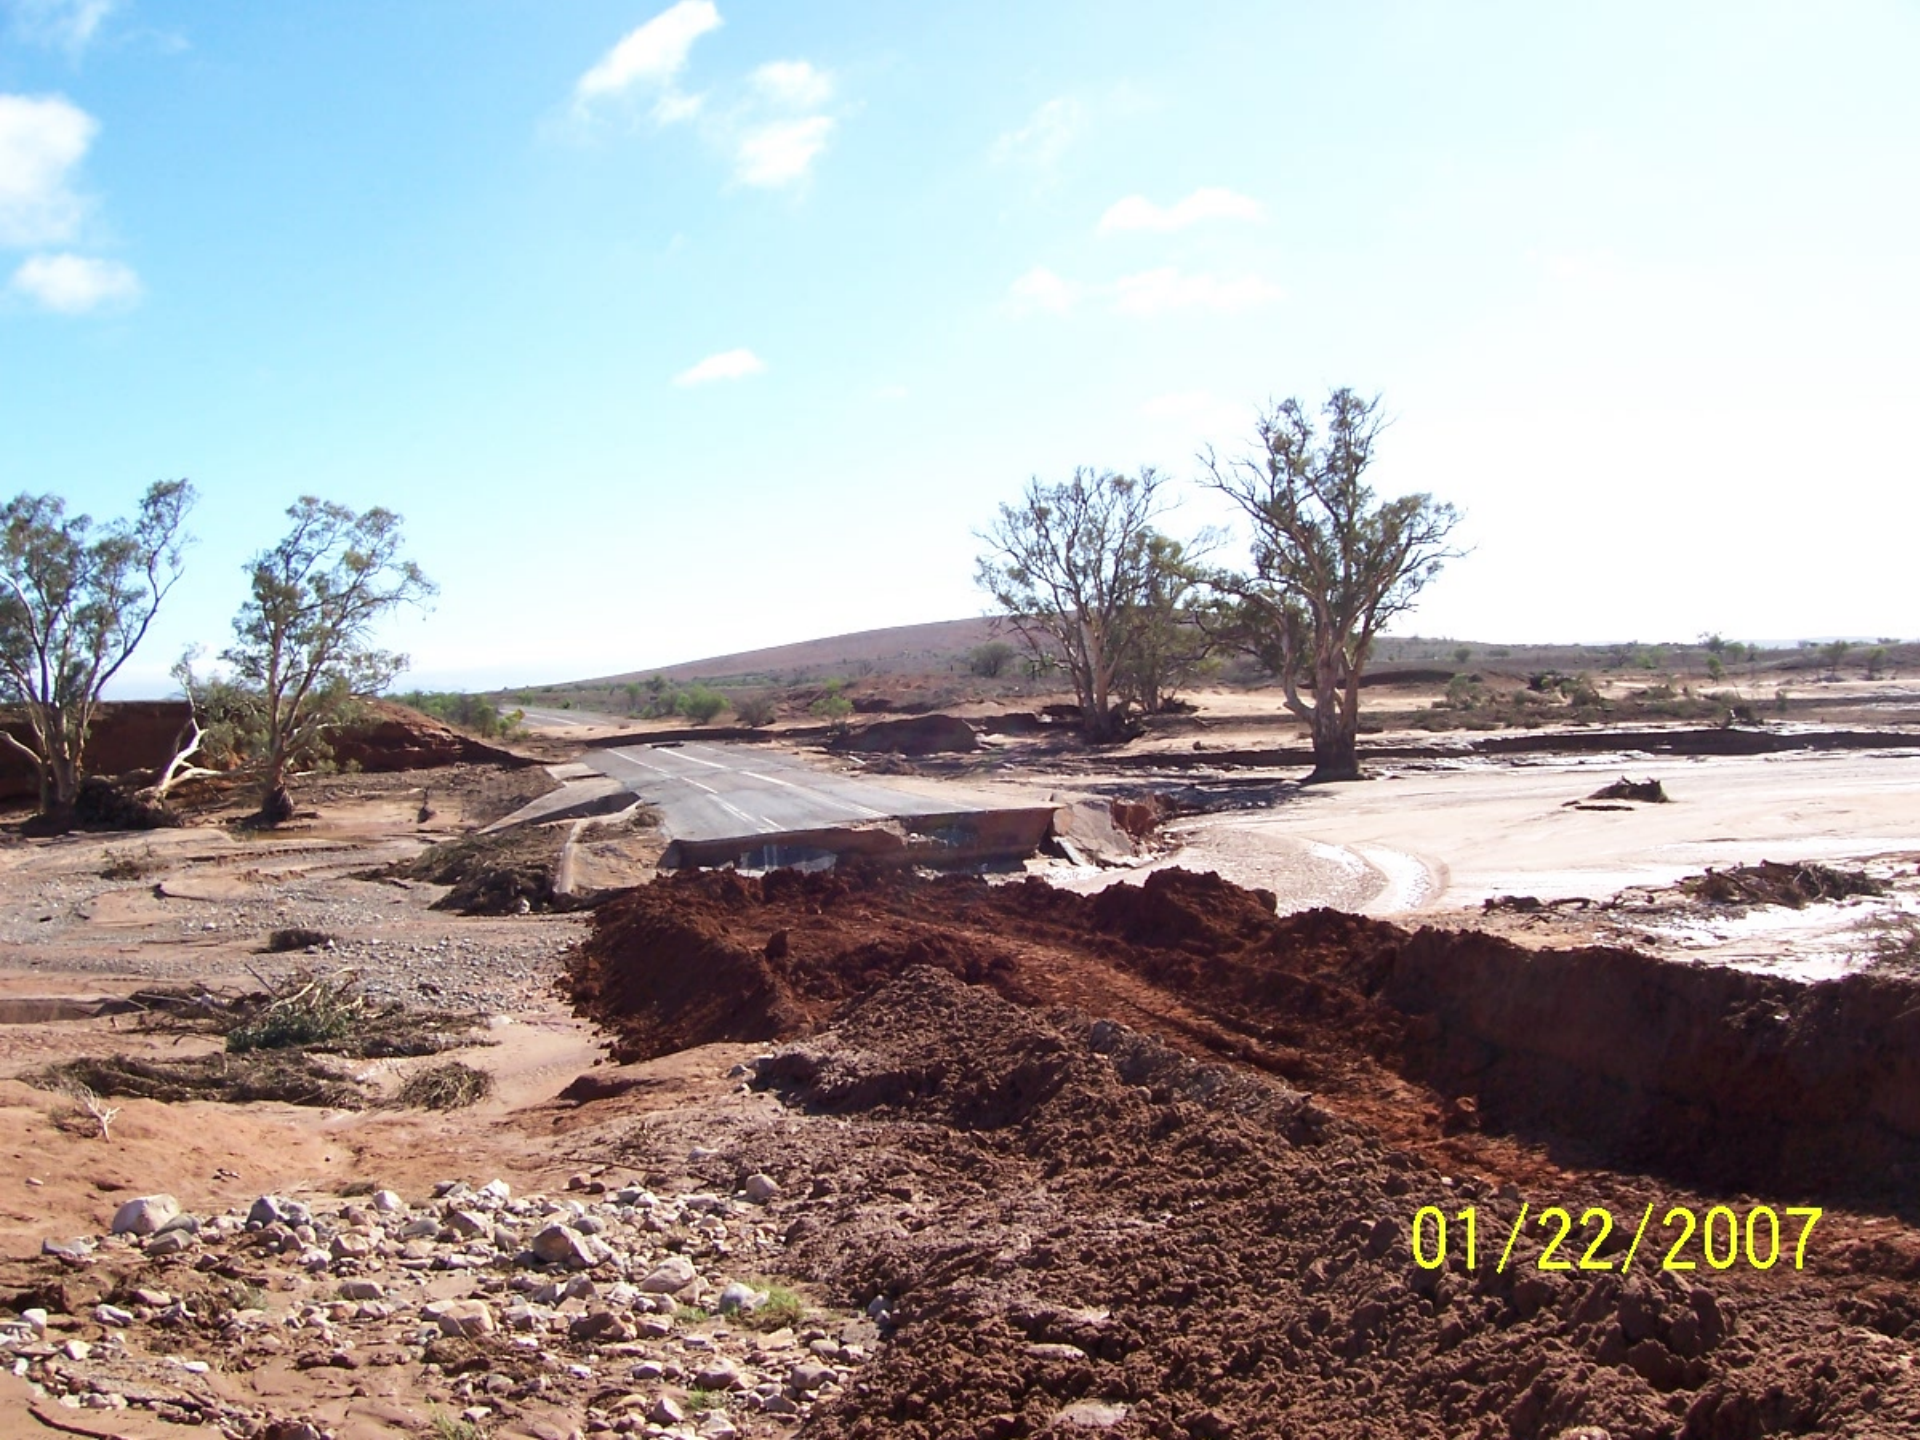
01/22/2007

- Peak intensities and damage near Hawker
- However had a widespread impact on roads in the far north
- Major damage to 3 floodways, and one other section of the Wilpena Road
- Minor damage to a number of other floodways
- Scouring of road shoulders

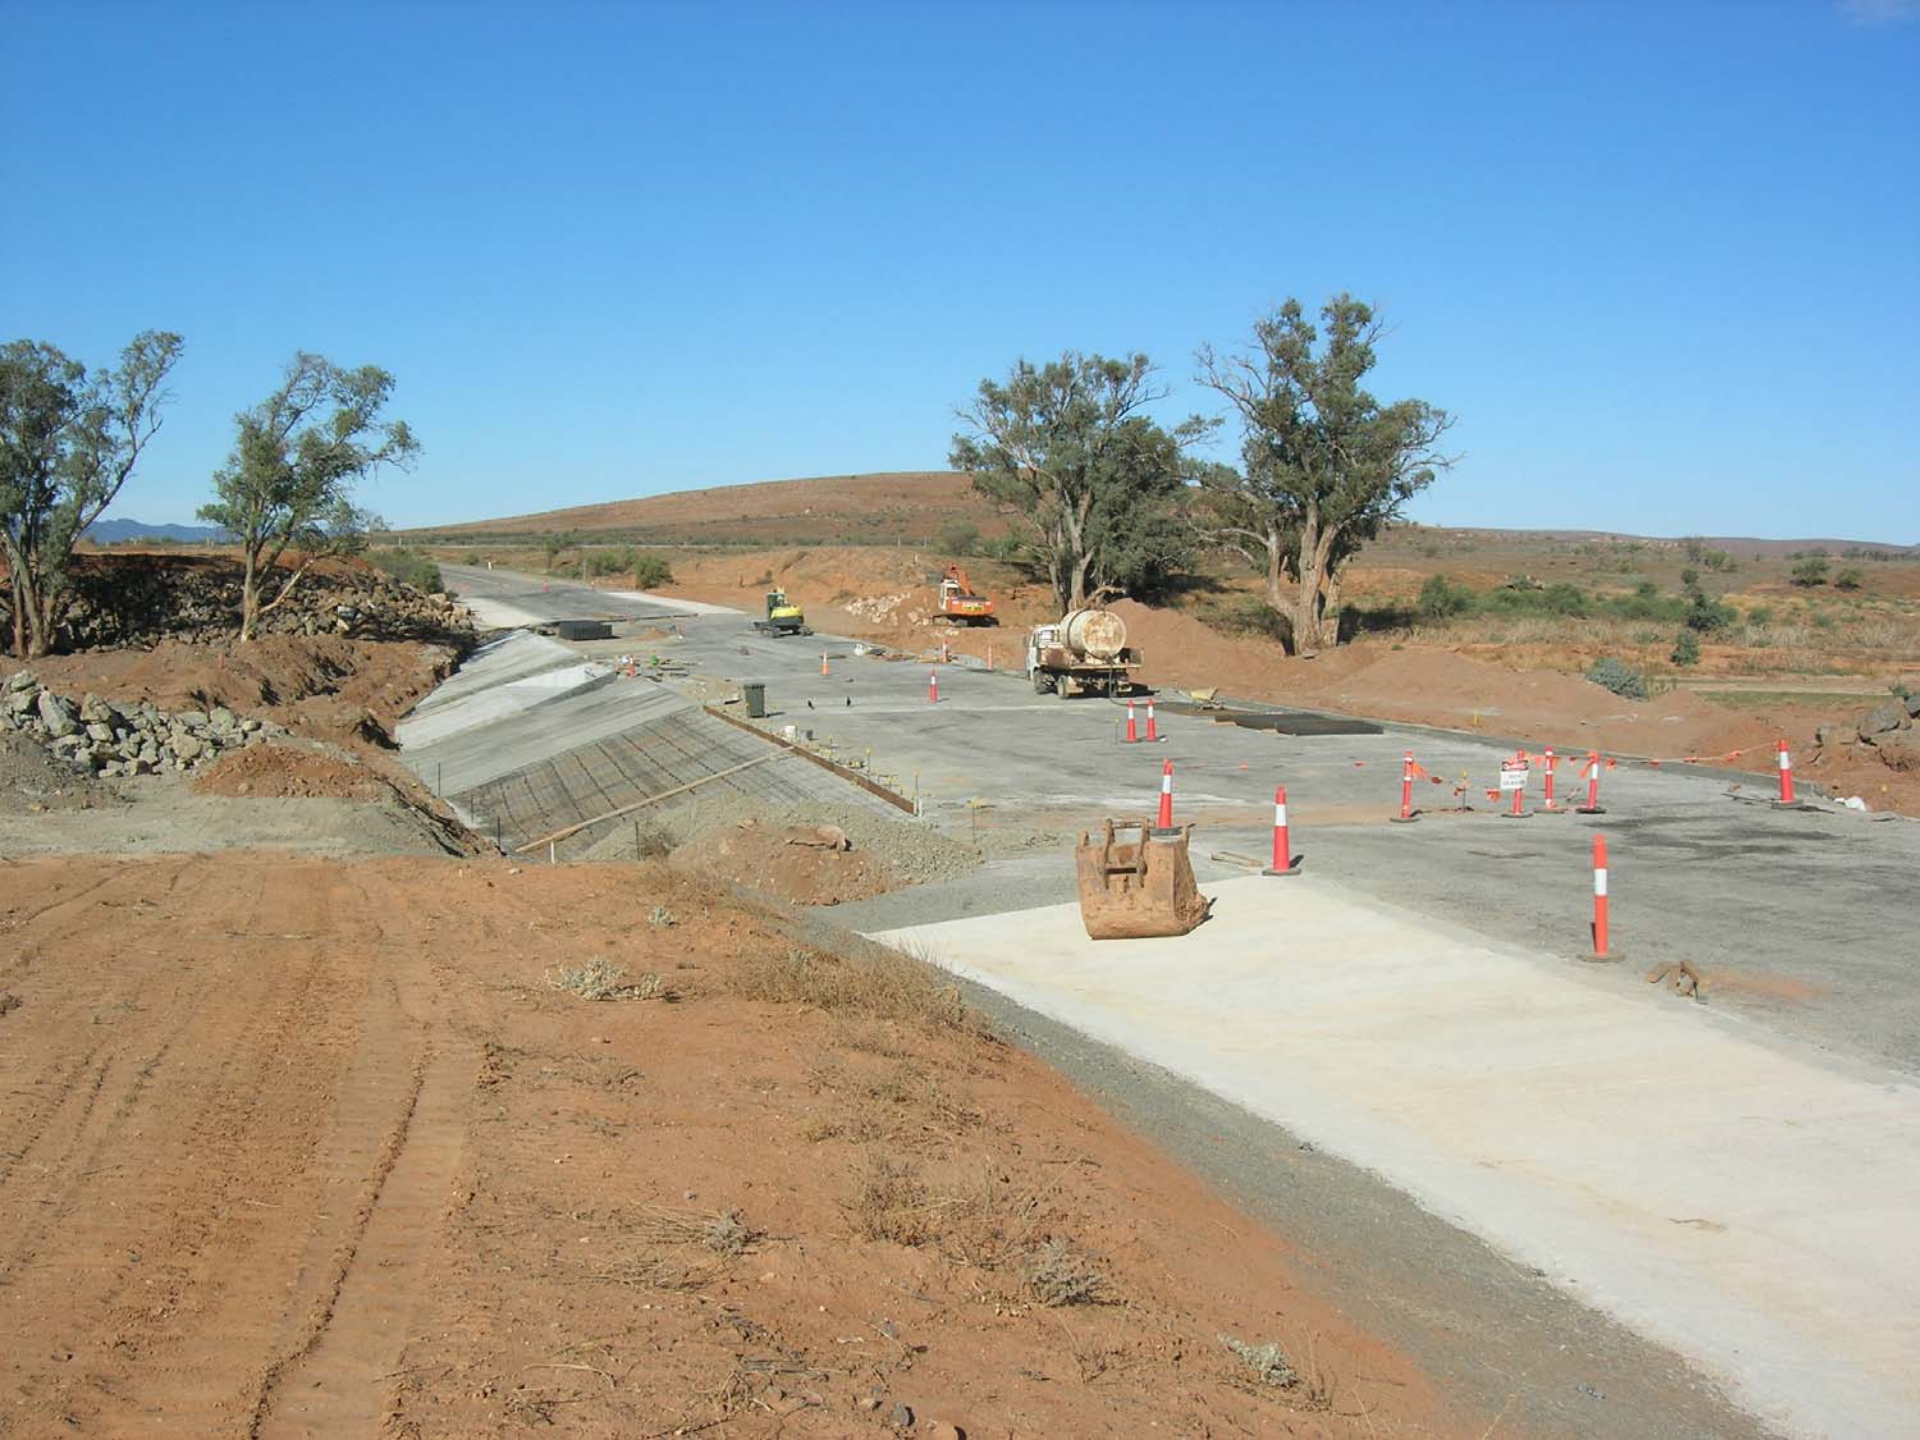
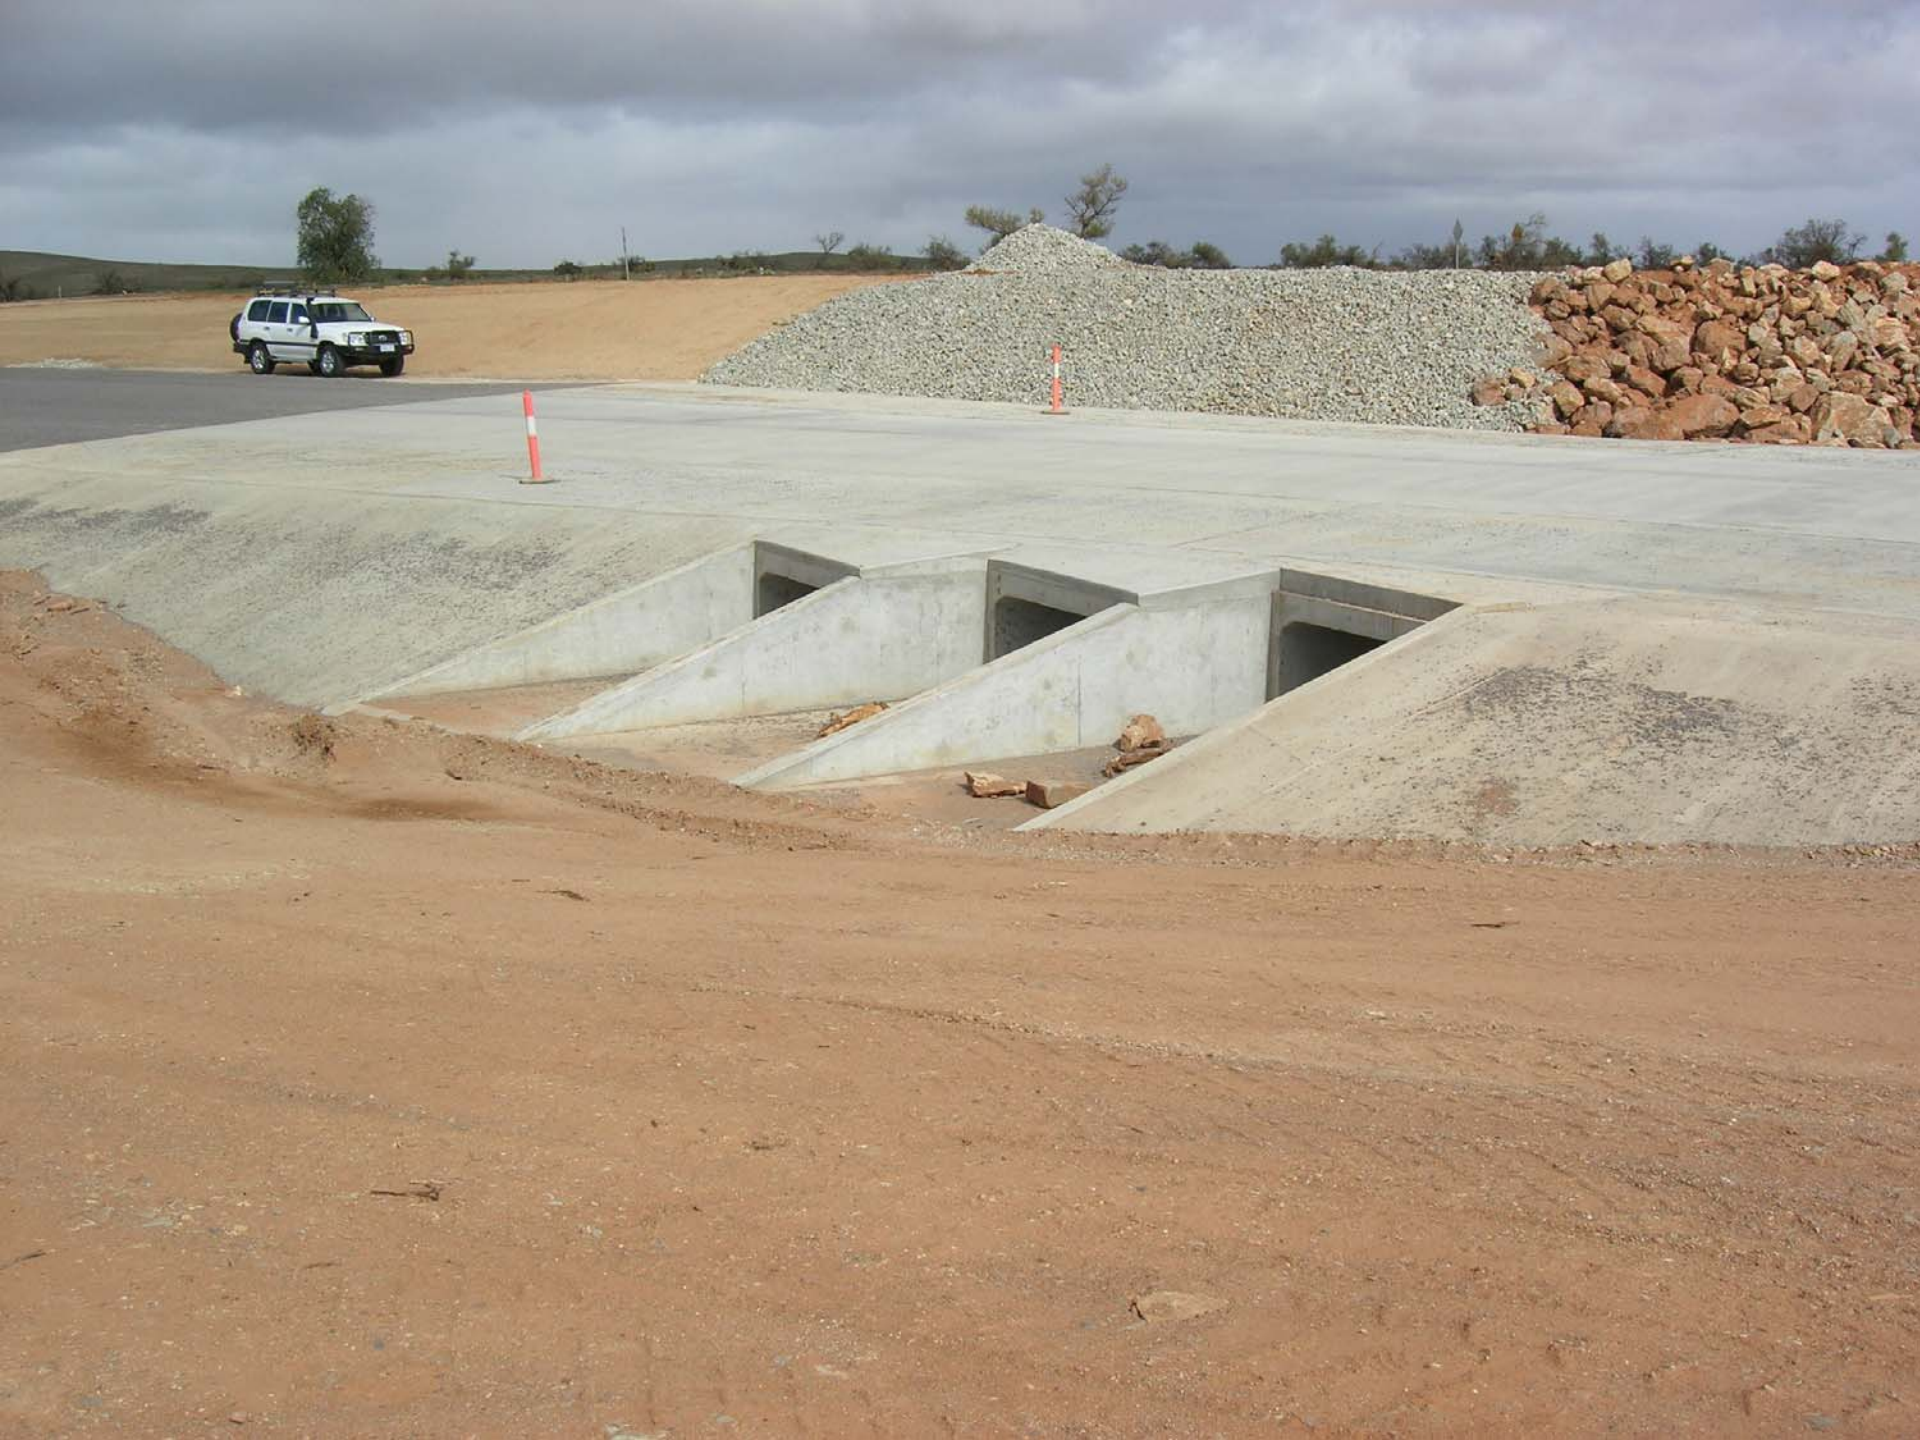
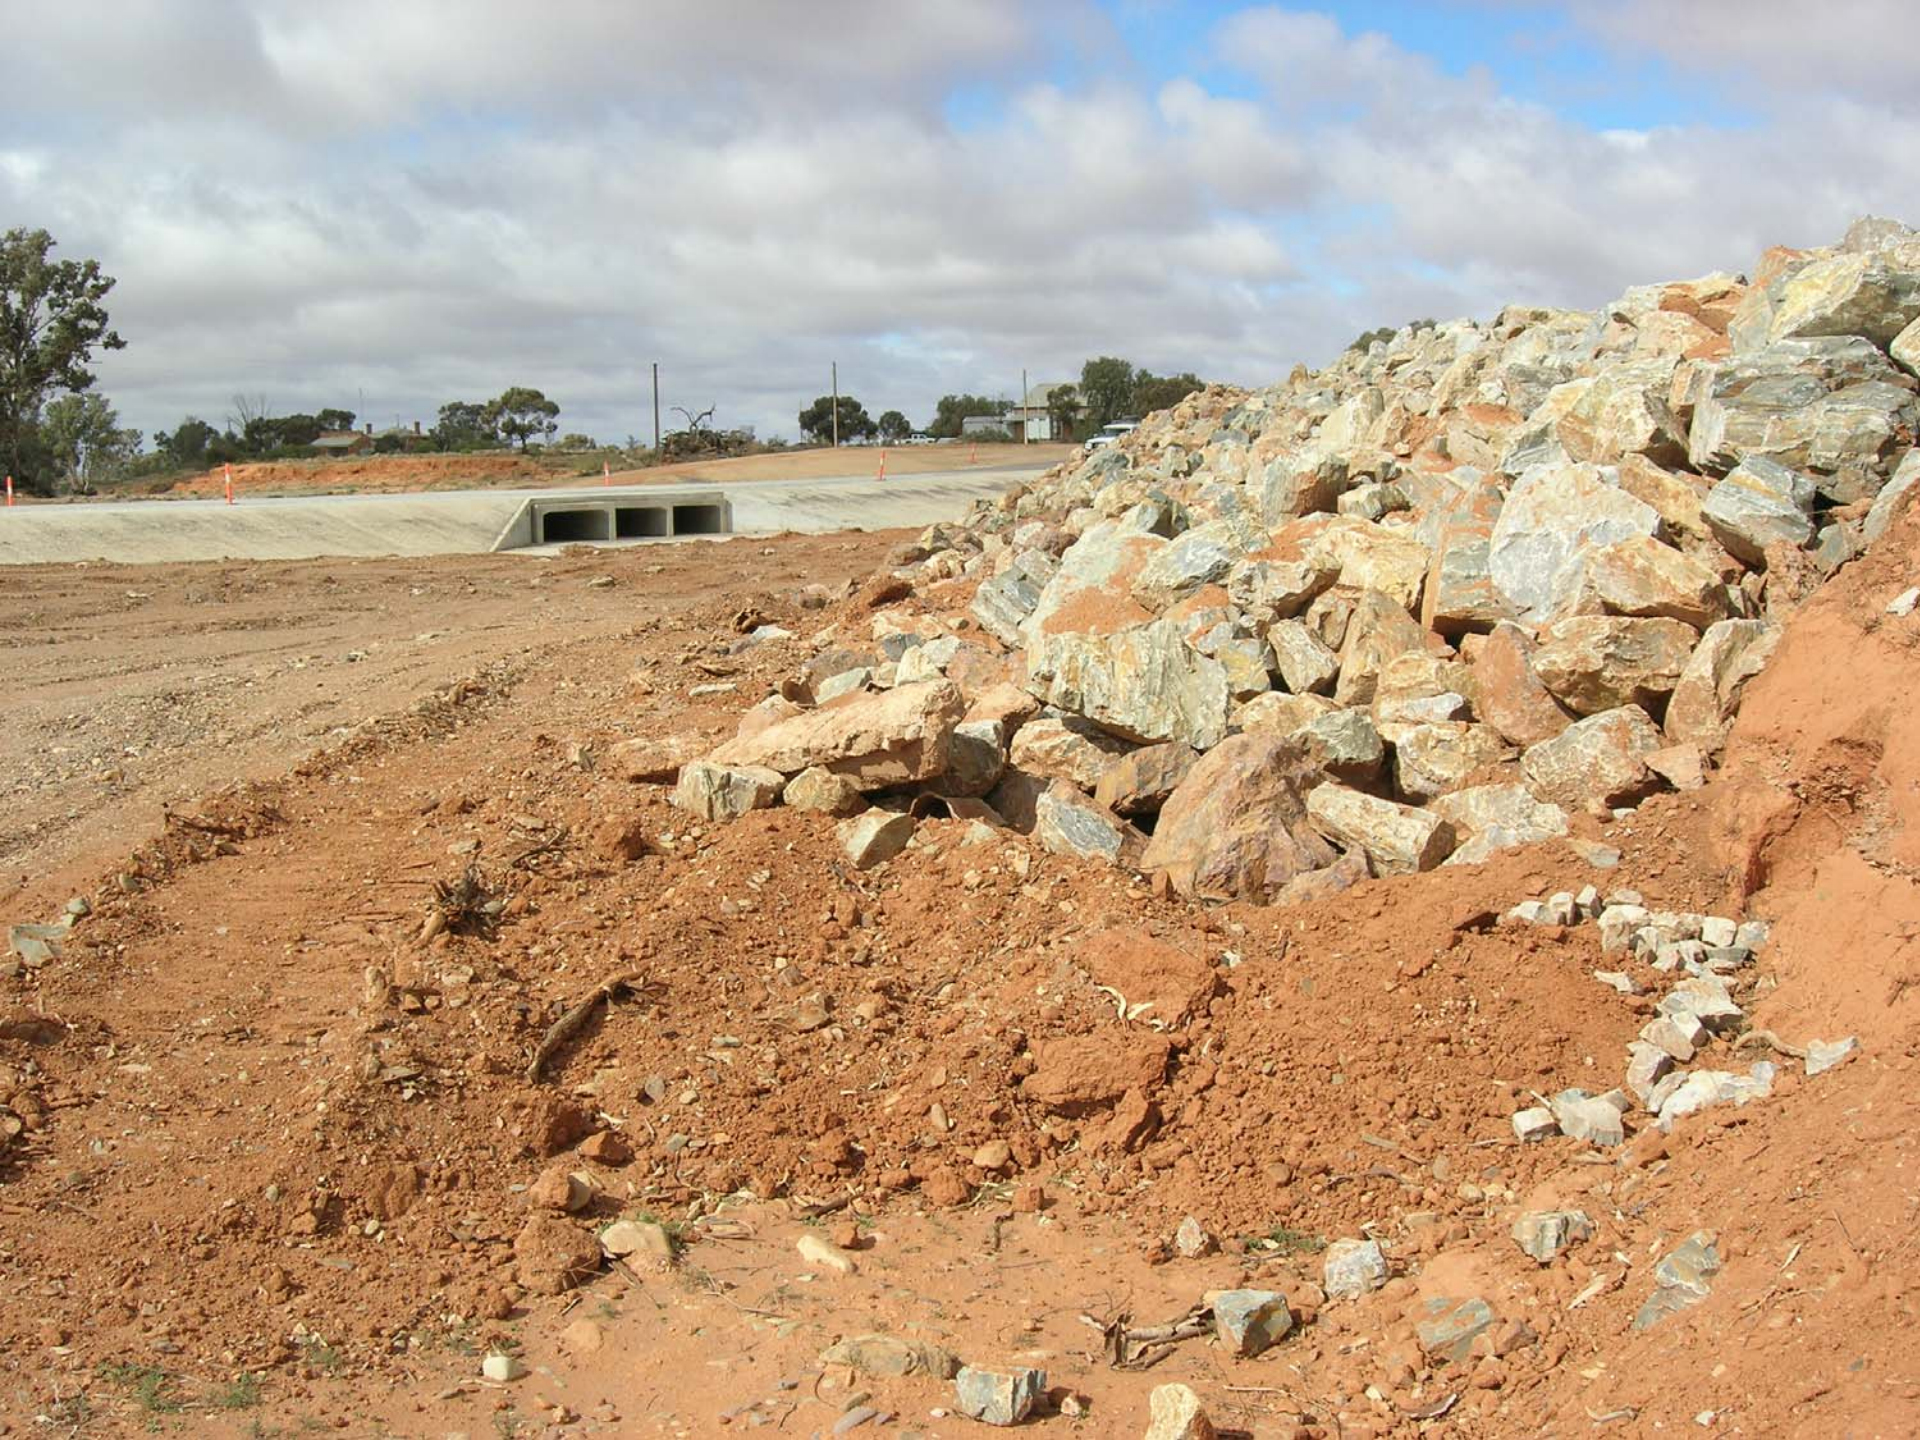
BATTERY & TEST PLAN				
FLORWAY ROAD CROSSING				
AMEND 1	DRAWN 25	DRG 5-4112	DATE OF ISSUE 10/1/00

- DESIGN**
1. FOR DIMENSIONS 'A', 'B', 'C', AND EXTENT OF PROTECTION REFER ROAD DRAWINGS.
- CONCRETE**
1. GRADE N-2.
2. REINFORCED CONCRETE MAY BE SUBSTITUTED WITH A 5M TABLE STRUCTURAL FIBRE REINFORCED CONCRETE, SUBJECT TO APPROVAL.
- REINFORCEMENT**
1. REINFORCEMENT MESH TO BE GRADE 50-11 IN ACCORDANCE WITH A311/23. 66.
2. REINFORCEMENT MESH TO BE PLACED CENTRALLY IN BATTER PROTECTION.
3. STANDARD HOOKS AND ENDS SHALL BE IN ACCORDANCE WITH A311/23. 66/4.
- COVER**
1. COVER TO BE 45mm ALL AROUND.

- Road pavement contained by cutoff walls
- Cement treated (low velocity) or concrete (high velocity) pavement
- Culverts for low flows – if possible. Be aware of debris
- Allow for changes in bed elevation

- Batter protection if floodway level above creek bed level
- Rounded at top of batter to reduce hydraulic uplift
- Use rock protection, but be aware of high velocities

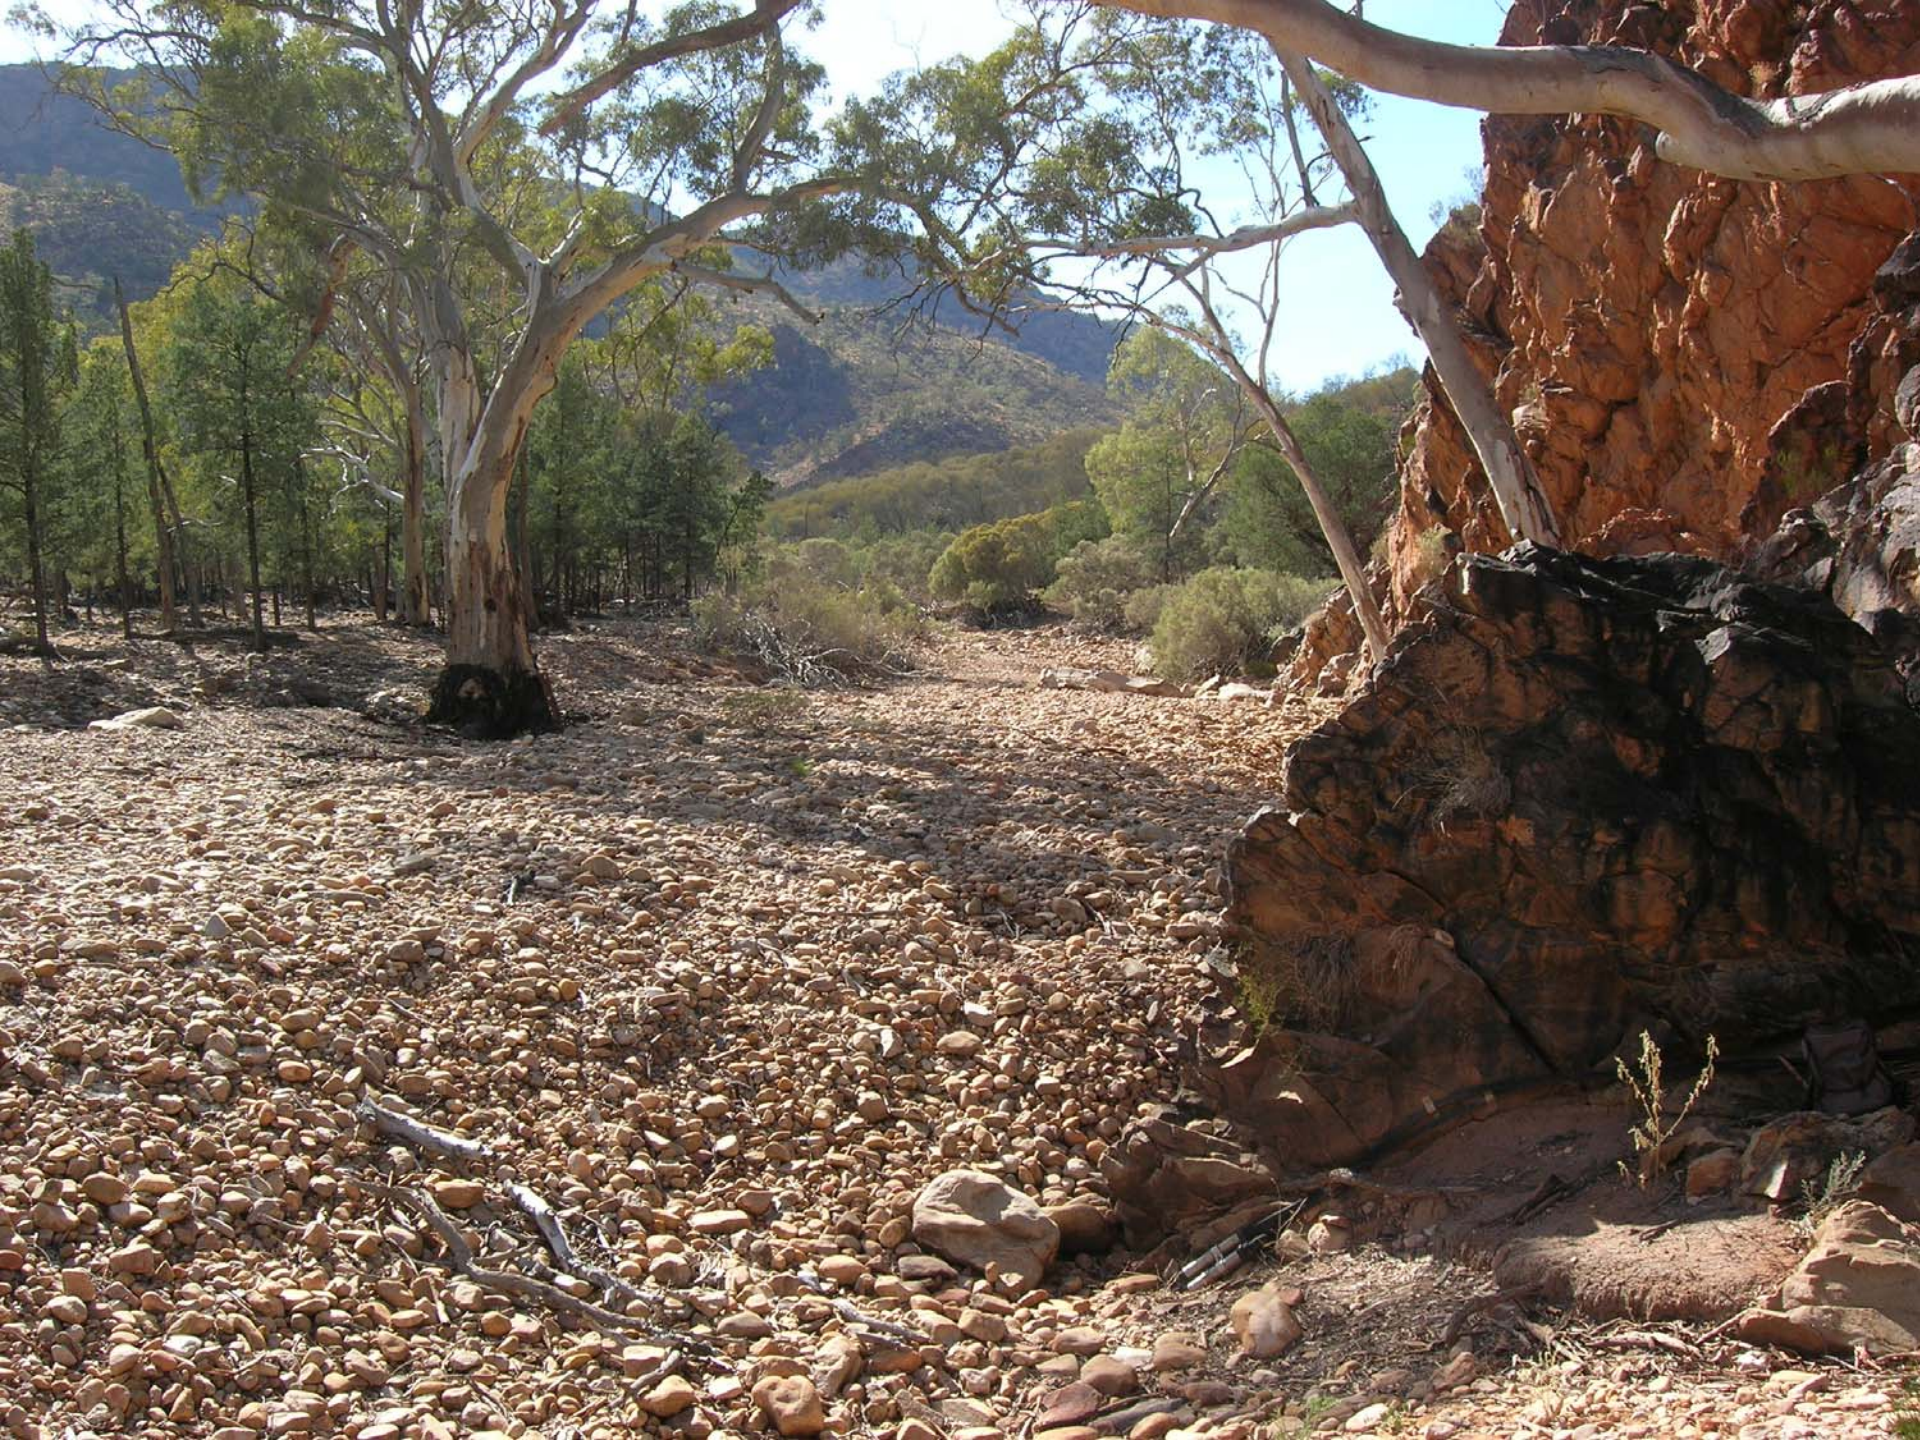
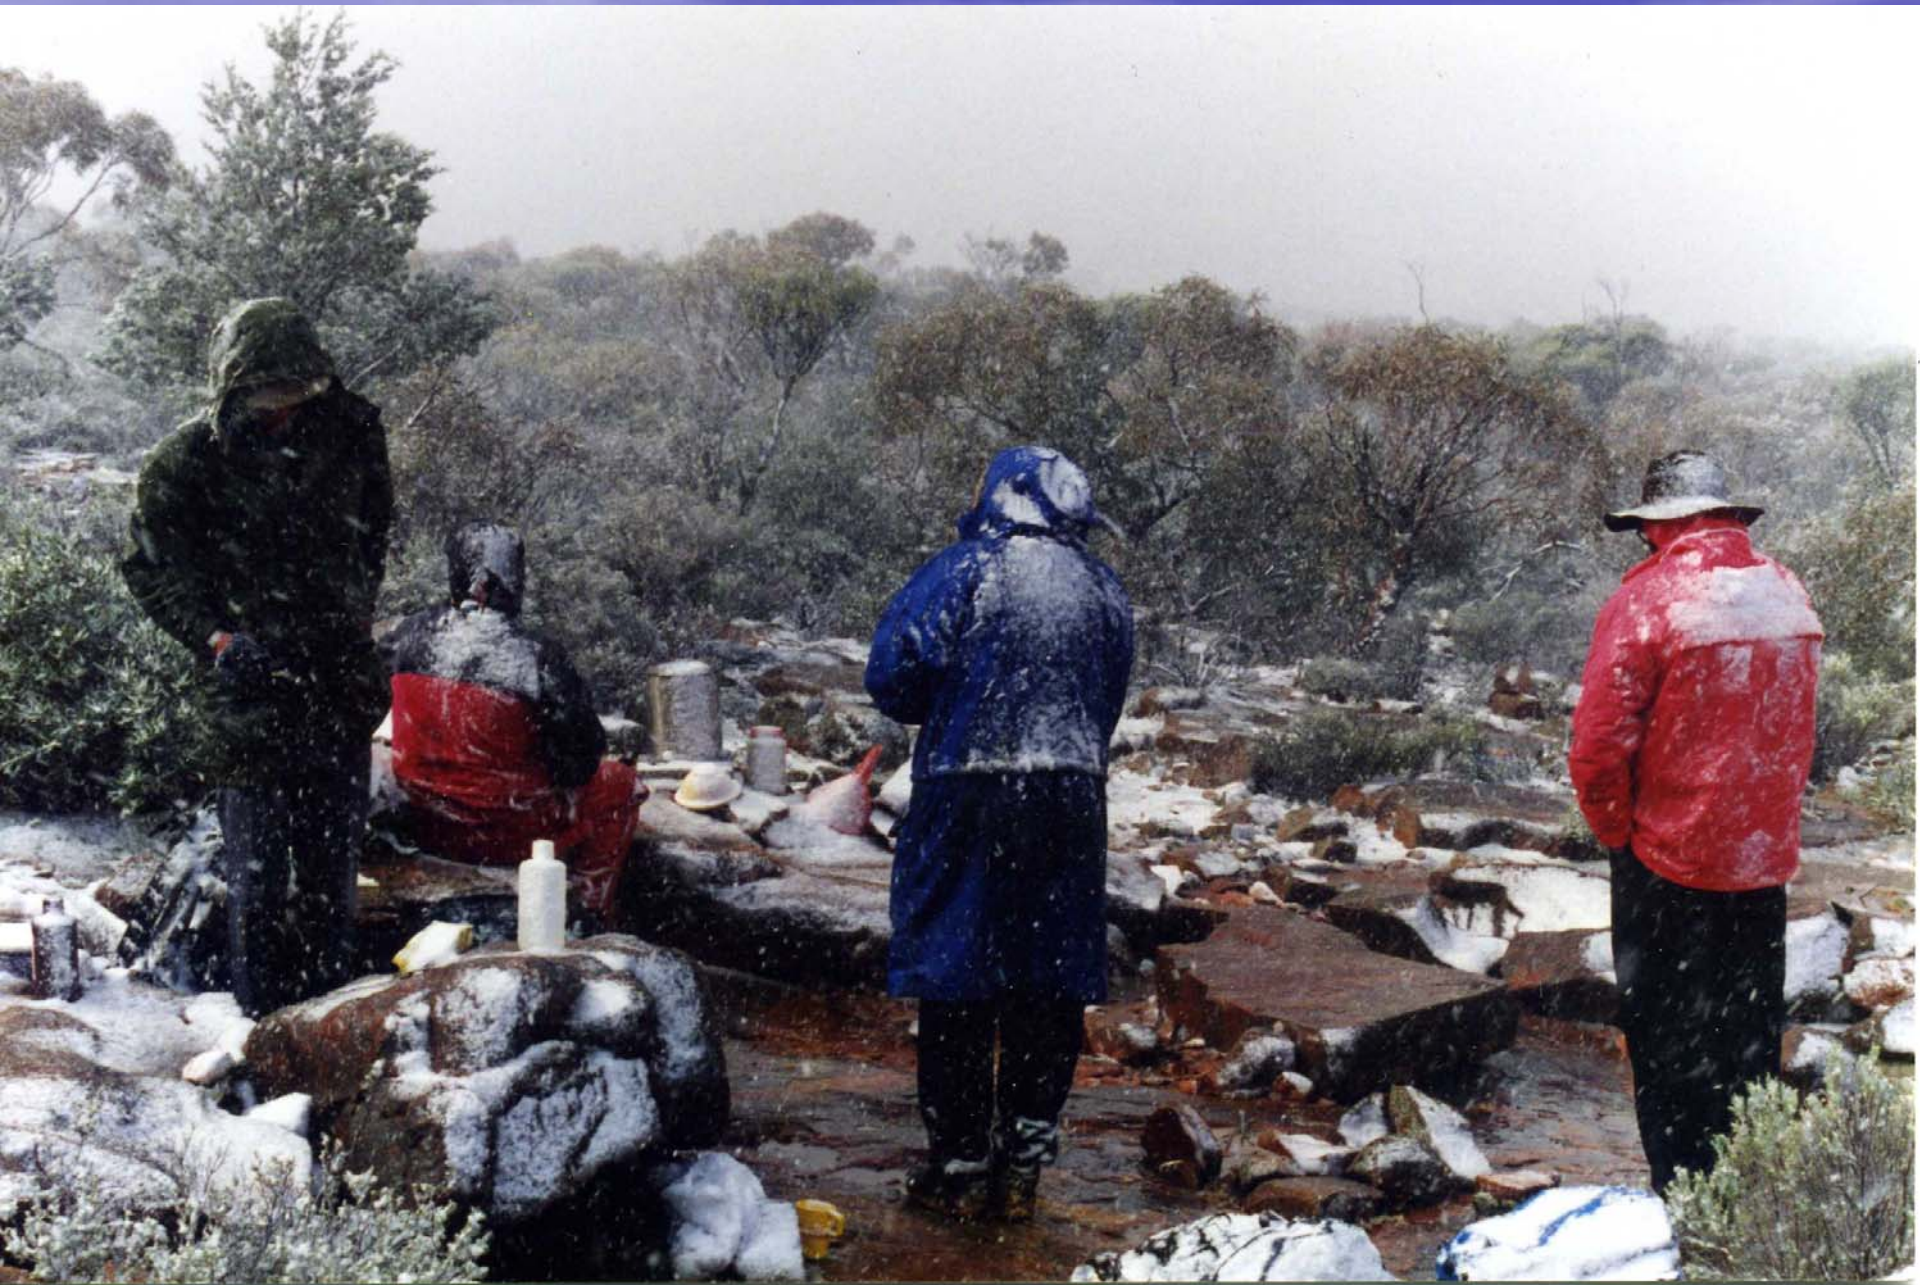
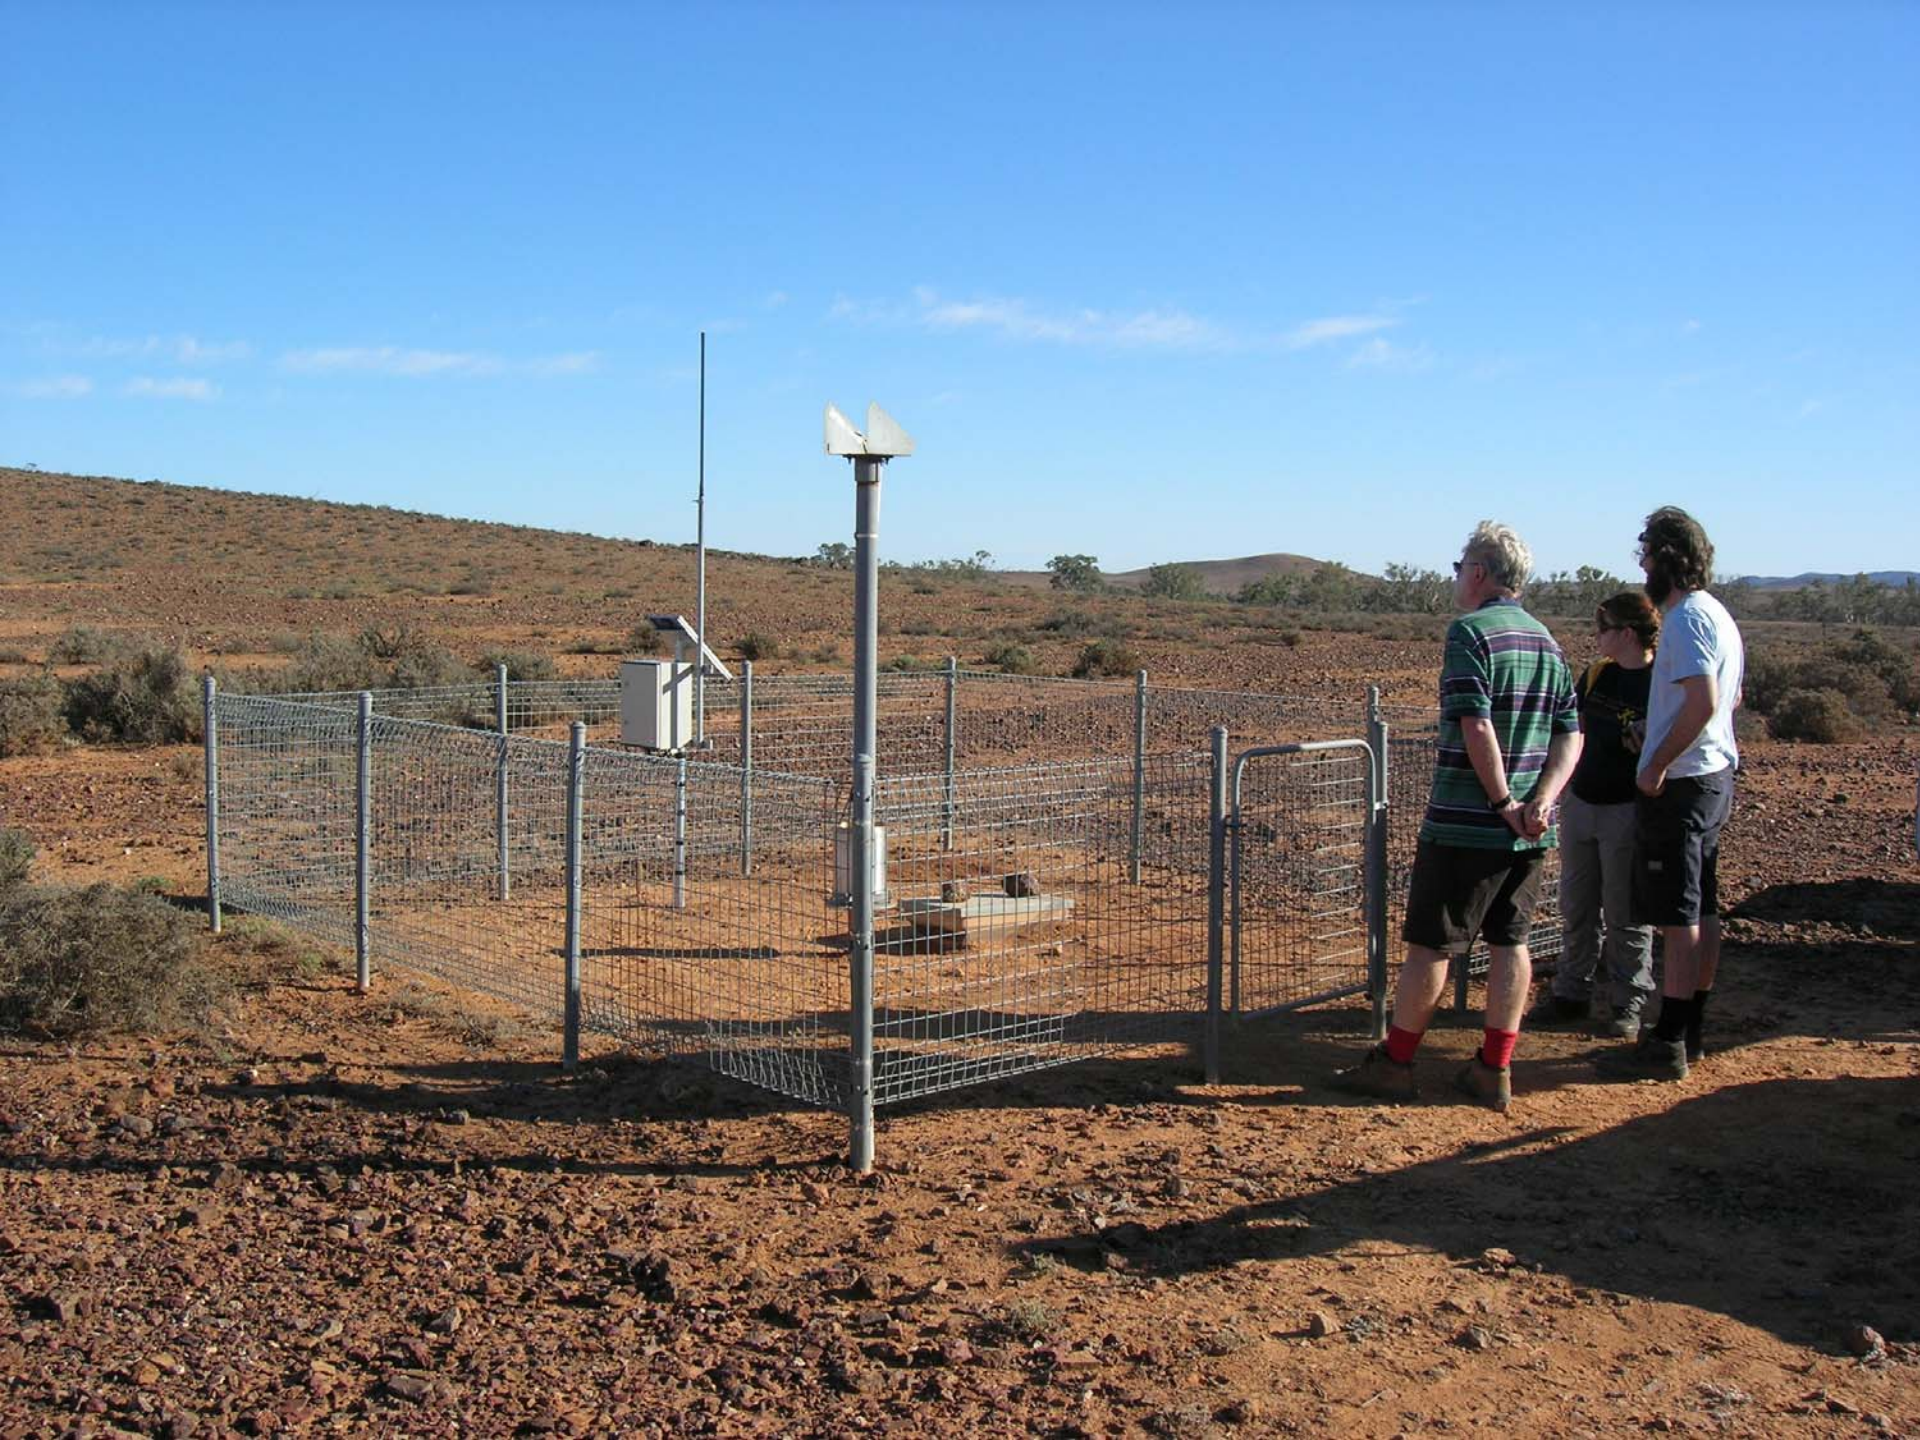
- Stream flow monitoring and electrical conductivity recording at one site on Arcoona Creek,
- Yellow footed rock wallaby colony monitoring, and
- Feral animal counts and locations.
