# Floods in South Australia's Arid Zone – Experiences and Challenges

David Kemp – DTEI, SA

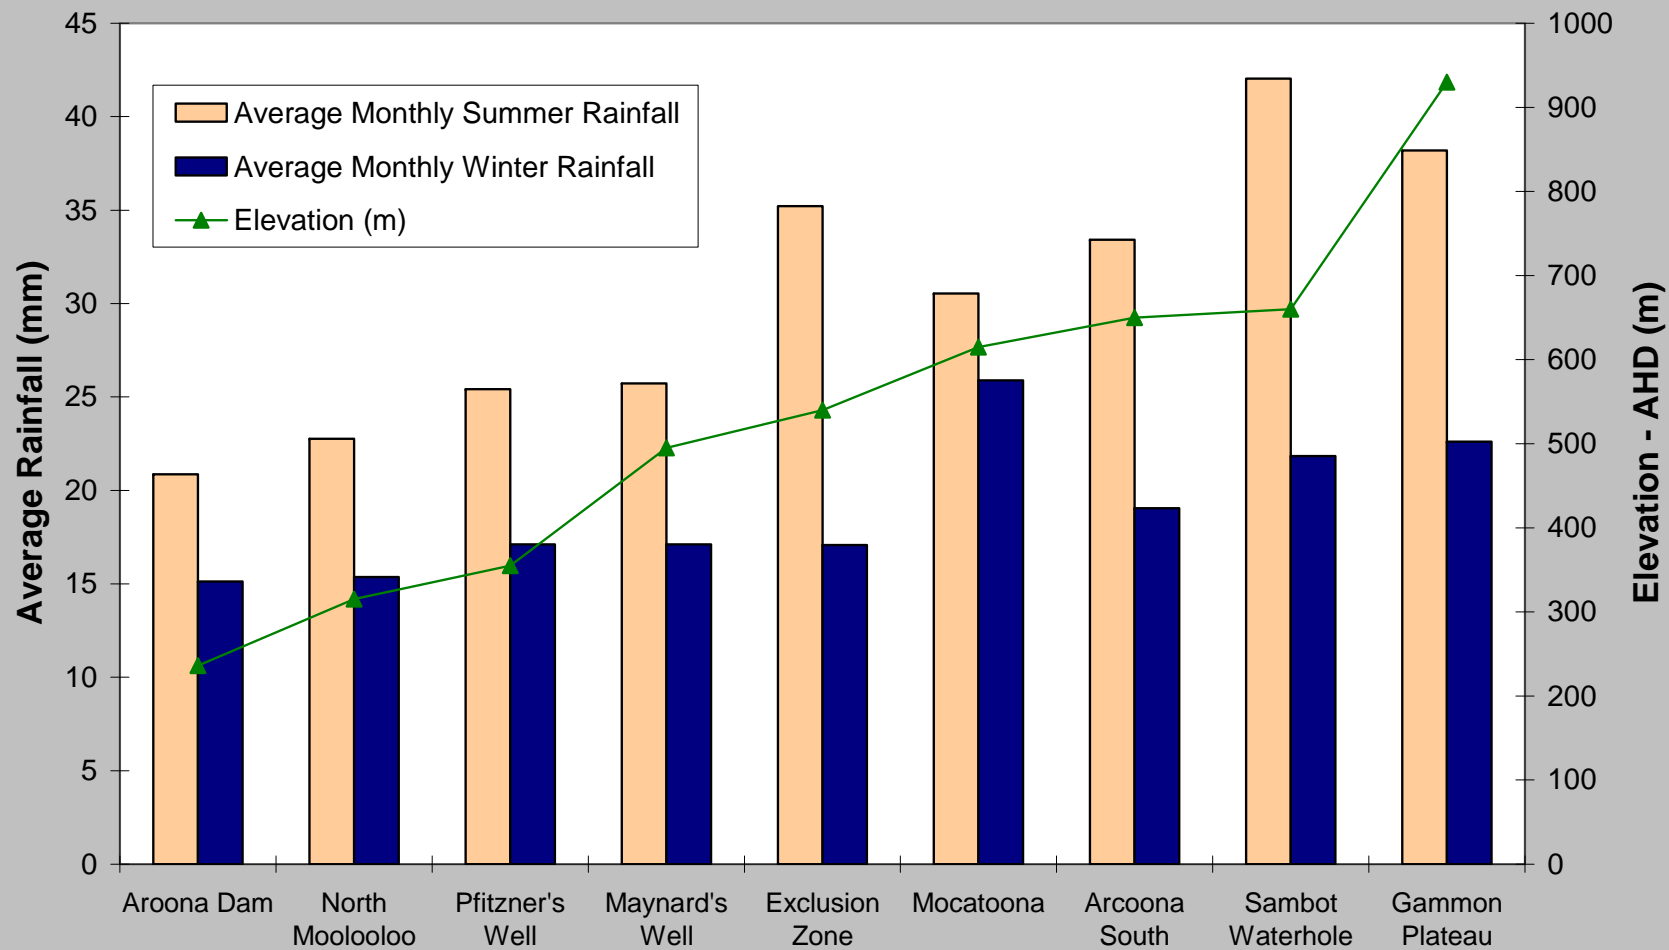
- Winter rainfall events are generally low intensity, with orographic effects.
- Summer rainfalls are either localised convective storms, or caused by slow moving tropical low pressure systems.
- There is very significant variability in rainfall, that masks any trends
